Portage Creek Sediment Remediation Project Kalamazoo, Michigan

Pre-Sediment Removal Structure Feature Assessment
Removal Areas SA5-Axtell, SA5-D and SA5-C

F&V Project Number: 809930
May, 2012

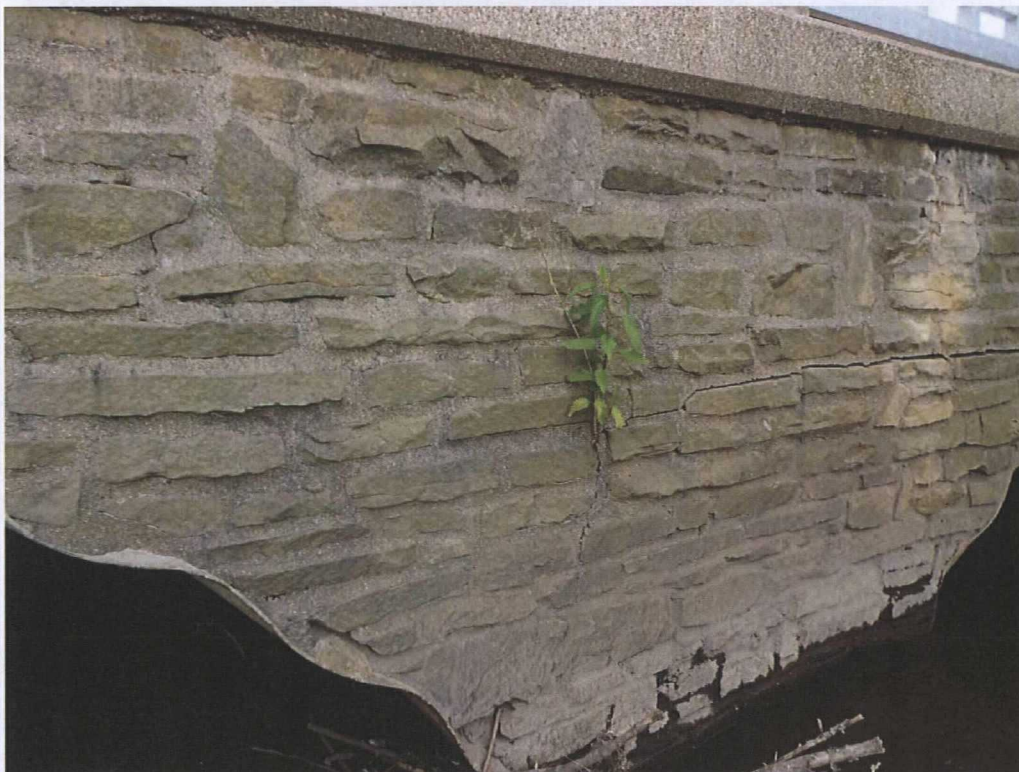
- There is severe horizontal cracking in the south headwall, approximately ½" wide from the high point of both culverts heading west. Scattered vertical cracking was noted as well.

Vegetation growth through cracking in south headwall

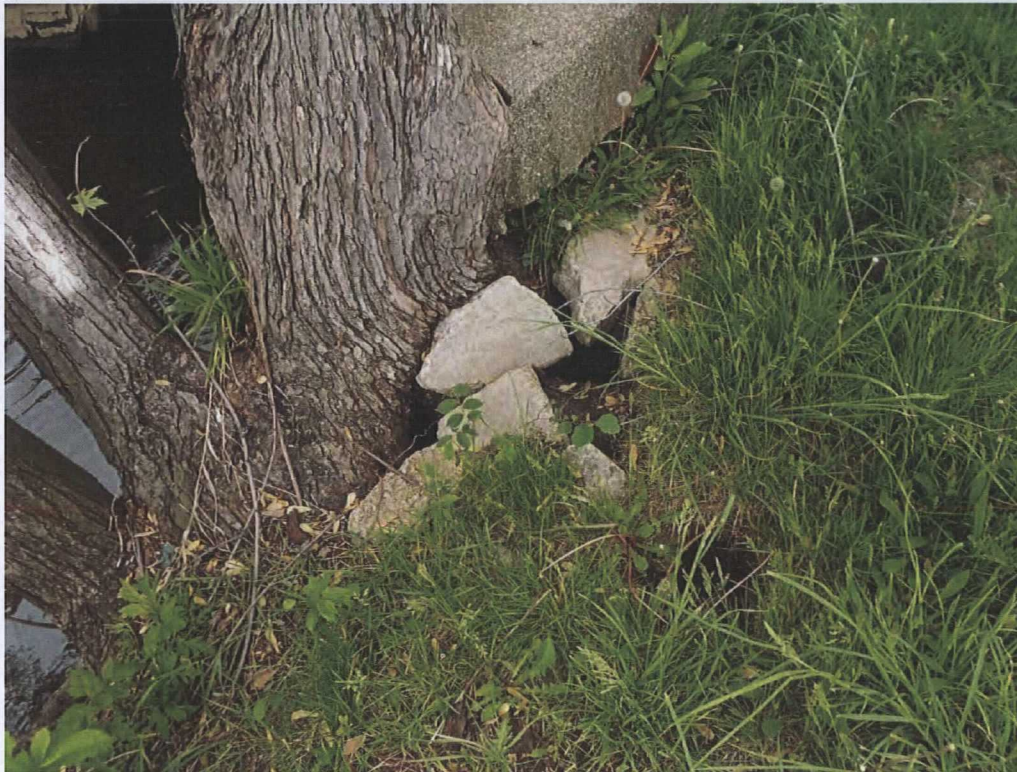
- Minor surface corrosion was noted on the culverts above the waterline and moderate to severe corrosion with scaling at the waterline.
- There is a large tree growing at the end of the southeast wingwall. The southeast wingwall has minor gaps and cracks in the mortar joints. There is a large sinkhole behind the wall filled with concrete rubble.

Sink hole filled with concrete rubble behind southeast wingwall

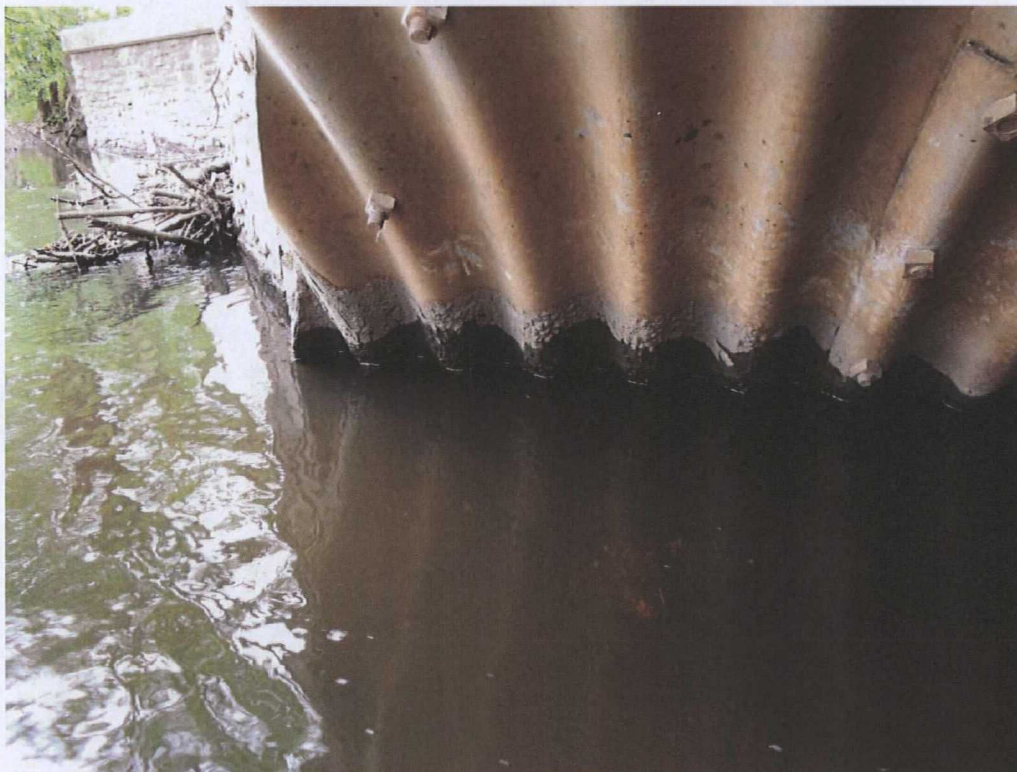
Corrosion and scaling of steel plate along waterline in southeast

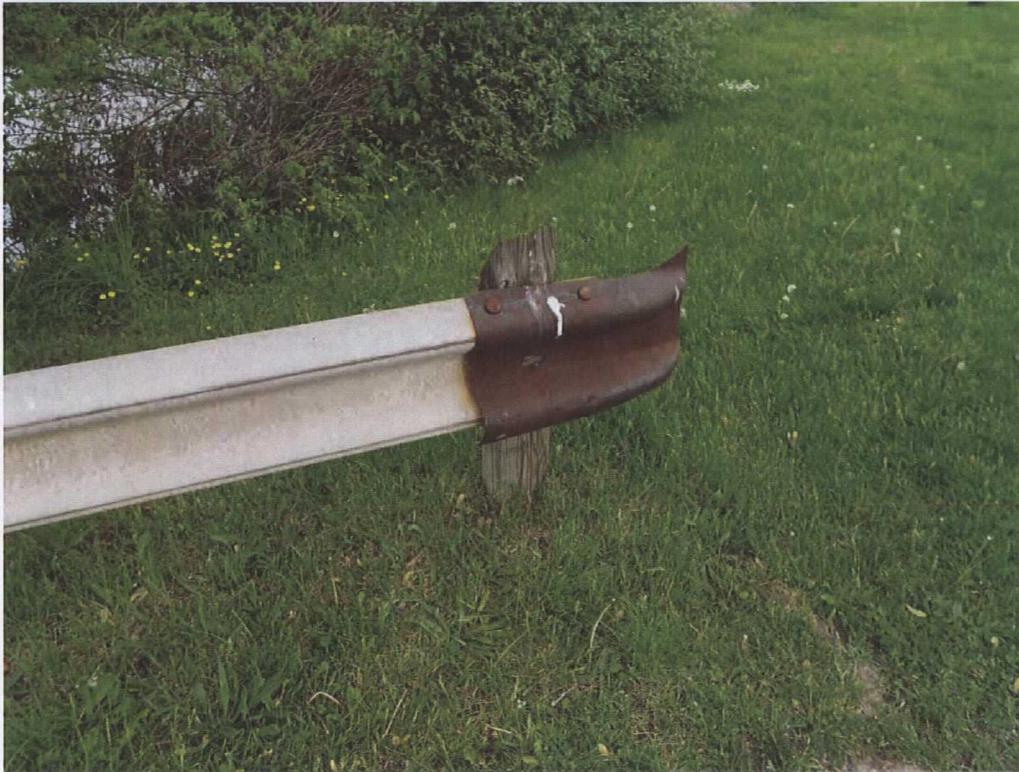
Corrosion on end of northeast approach guardrail

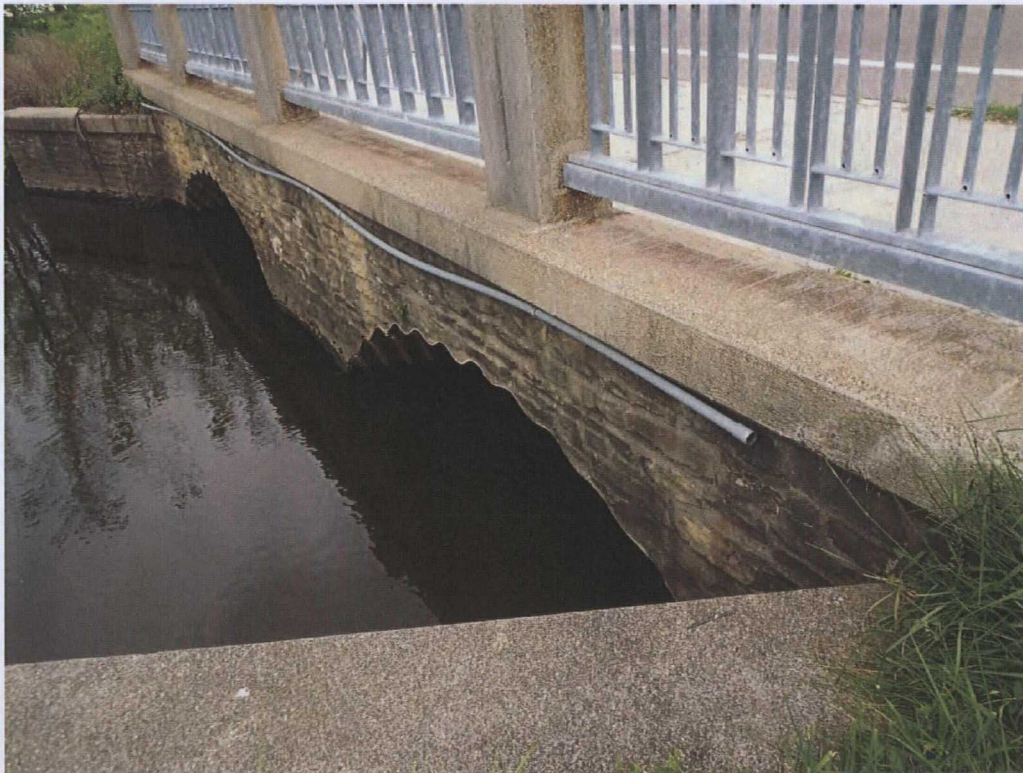
- There is an unidentified steel cover in the northwest and an abandoned conduit on the north headwall.
- Severe erosion was noted around the northwest wingwall with failed concrete rubble placed as riprap. Minor gaps and cracks were noted in the mortar joints.

Abandoned conduit on north headwall

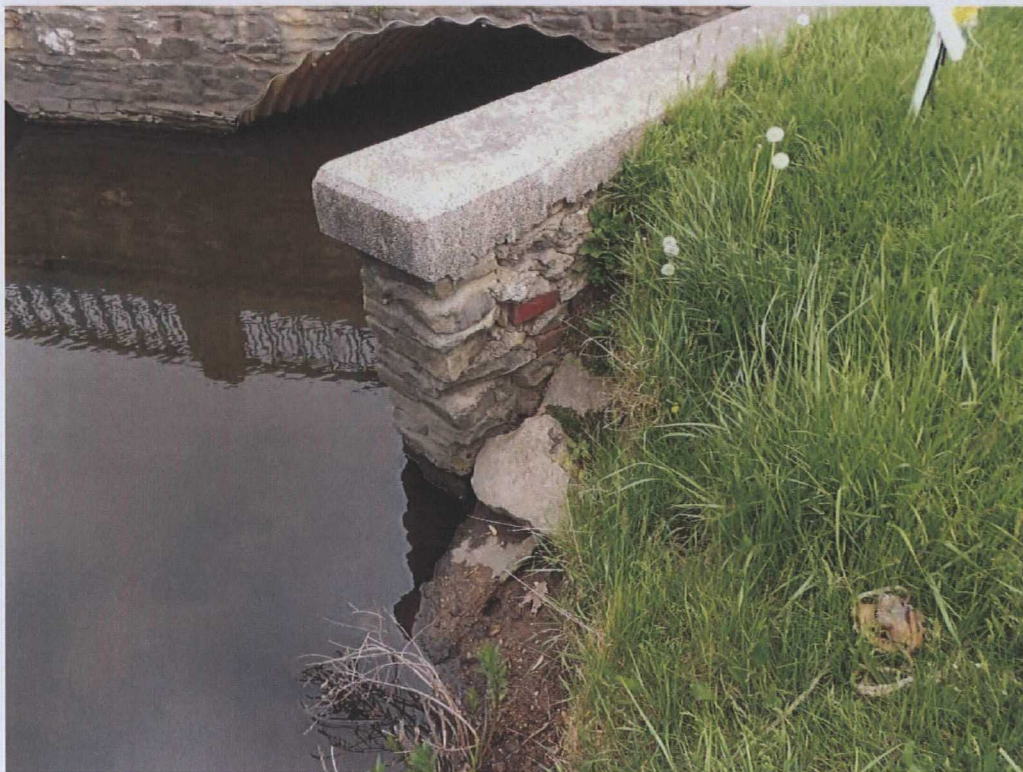
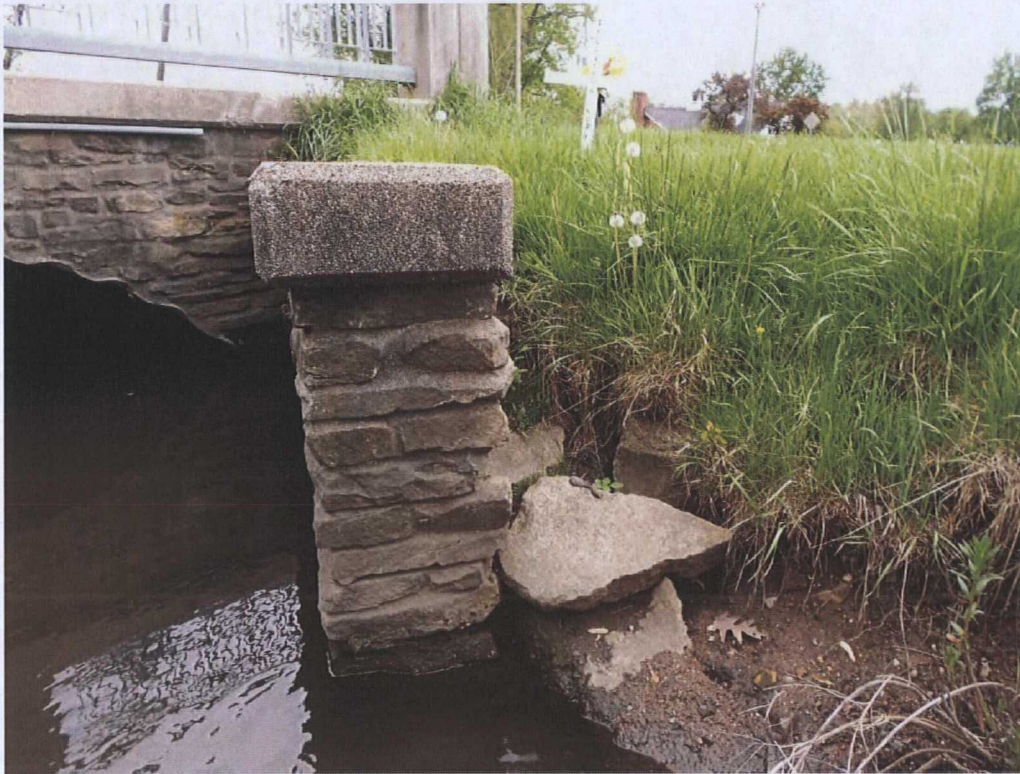
Bank erosion around northwest wingwall

Bank erosion around northwest wingwall with concrete rubble riprap

- The wingwalls and headwalls are masonry-type construction with various degrees of cracking and are more susceptible to damage from vibration than concrete. Therefore it is recommended that the cofferdams at the Crosstown Parkway bridge be constructed of sand bag walls, placed with approximately 4' clearance from the walls.
- The unidentified steel cover in the northwest should be excavated and opened prior to cofferdam installation to check for a possible utility crossing.

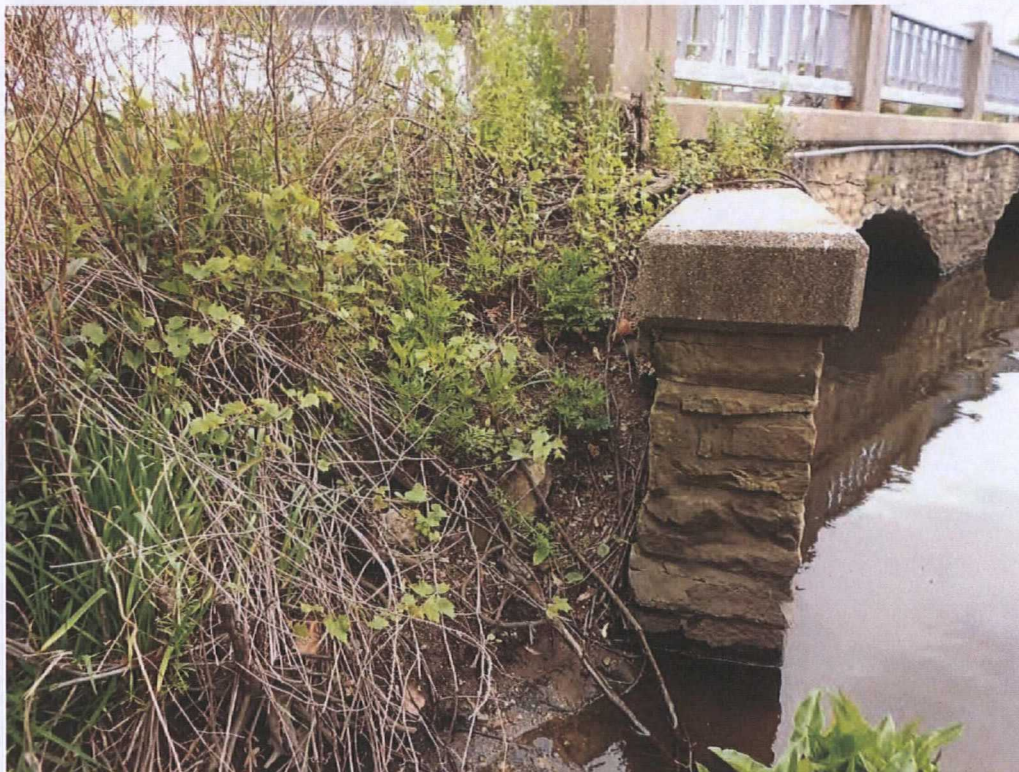
- The channel has deepened in the northeast however no footing was detected.
- Minor gaps and cracks were noted in the northeast wingwall mortar joints. The wall is overgrown with vines. Moderate erosion was noted behind the wall.

Bank erosion around northeast wingwall

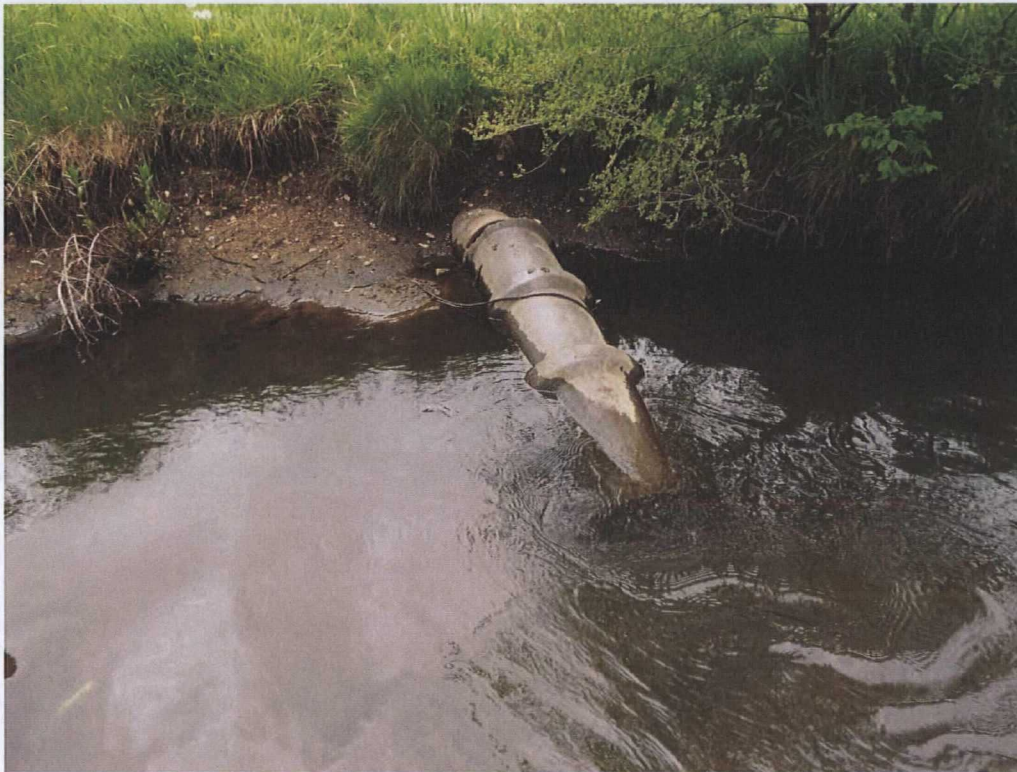
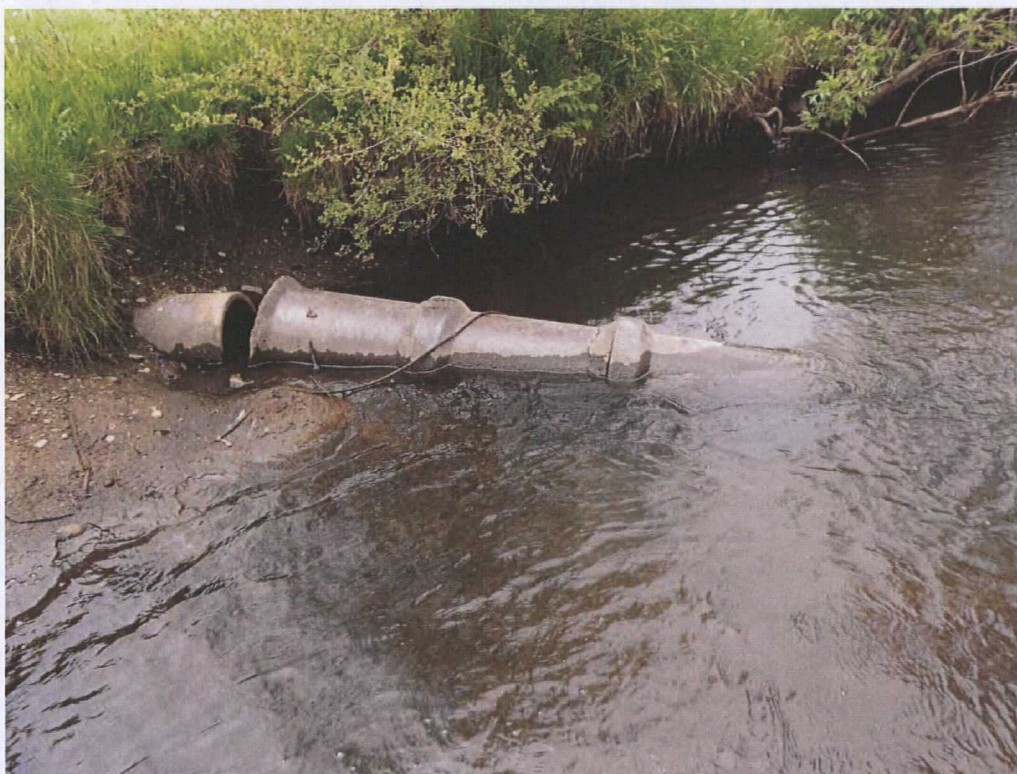
- There are 3 failed sections (~6') in the channel and the 4th exposed approximately 12" from severe bank erosion.

View of structure from the channel

View of structure from the upstream channel

- Remove the 3 failed sections. Protect the outlet with an isolation cofferdam to allow for dewatering.

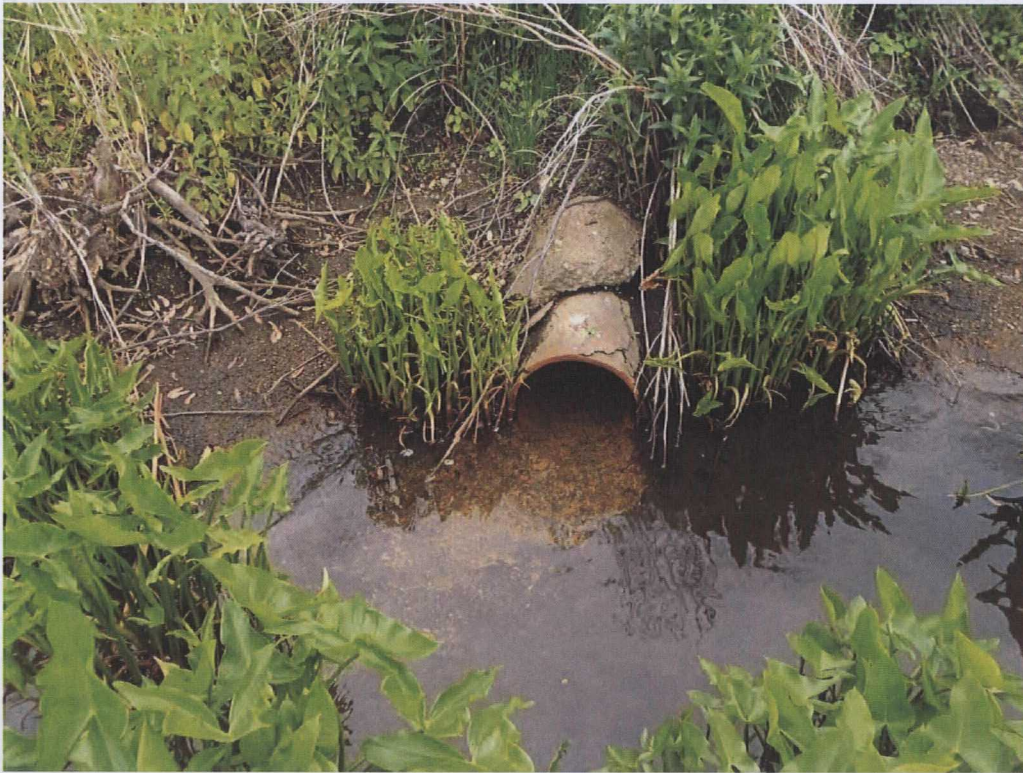
- The end of the pipe is exposed ~12" from bank erosion in the area. It is severely cracked and scaled.
- The concrete collar around the pipe is severely spalled.

View of structure from the channel

- Install a cofferdam to protect the structure and allow for dewatering. Provide approximately 2' clearance from the pipe.

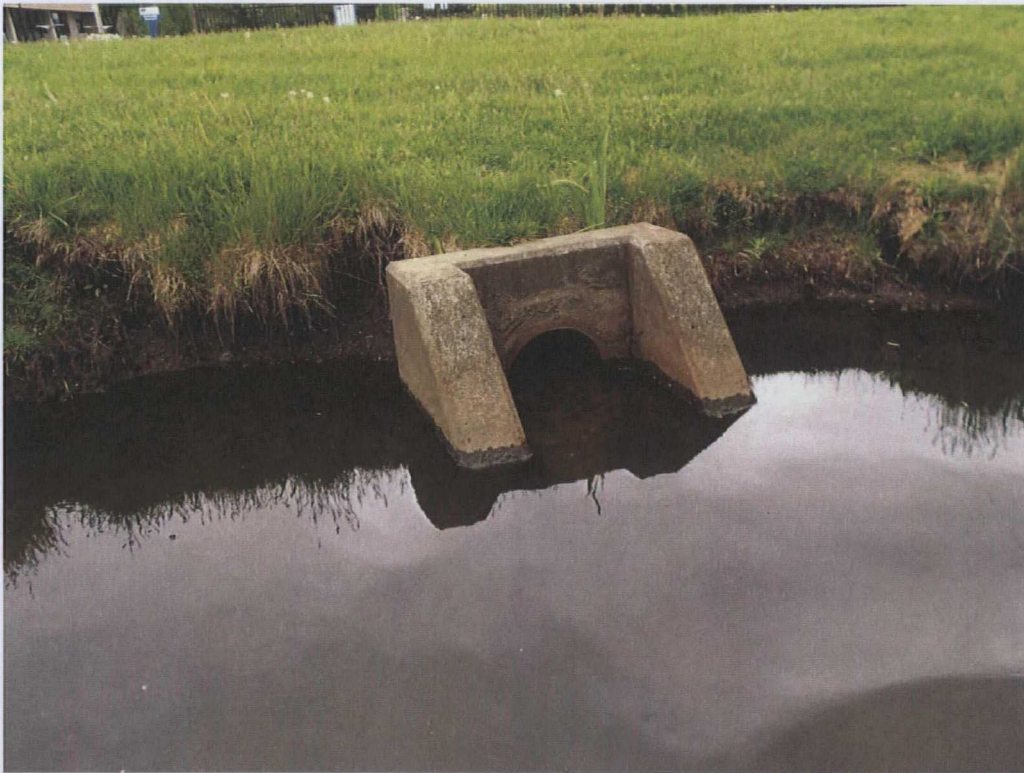
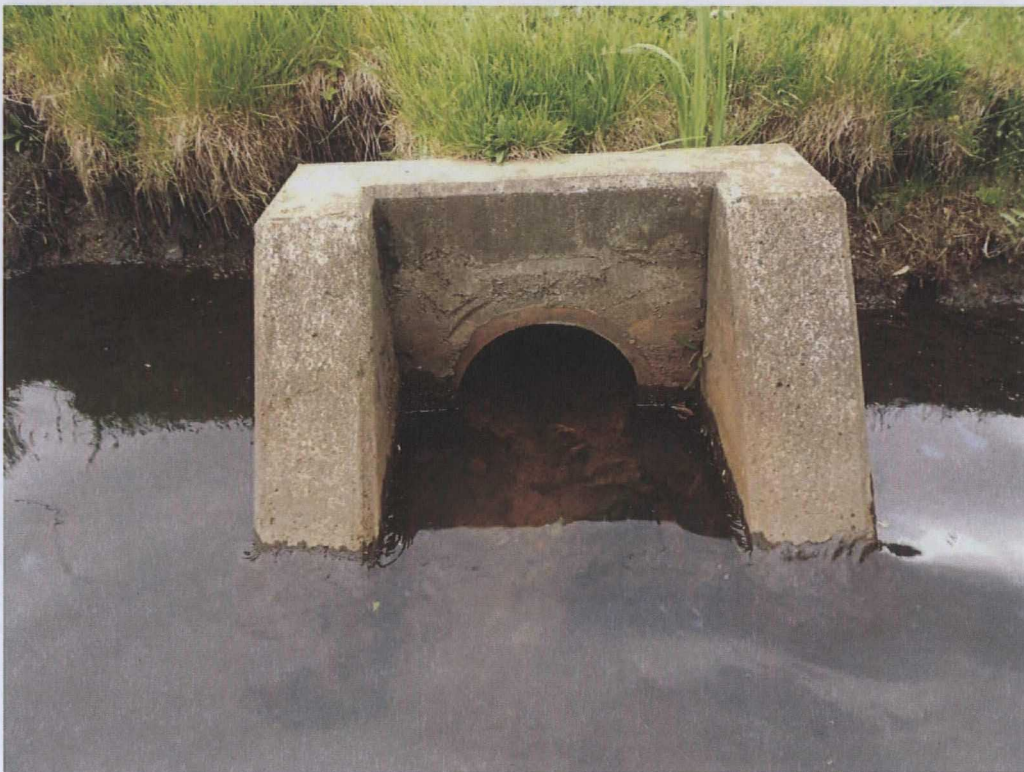
- Severe bank erosion has exposed the pipe behind the headwall on the south side and nearly exposed it on the north side. The bank is cut approximately 2' behind the headwall.
- No significant deterioration was noted on the pipe or headwall.

View of structure from the channel

Close-up of the concrete headwall

- Install a cofferdam to protect the structure and allow for dewatering. Provide approximately 2' clearance from the headwall.

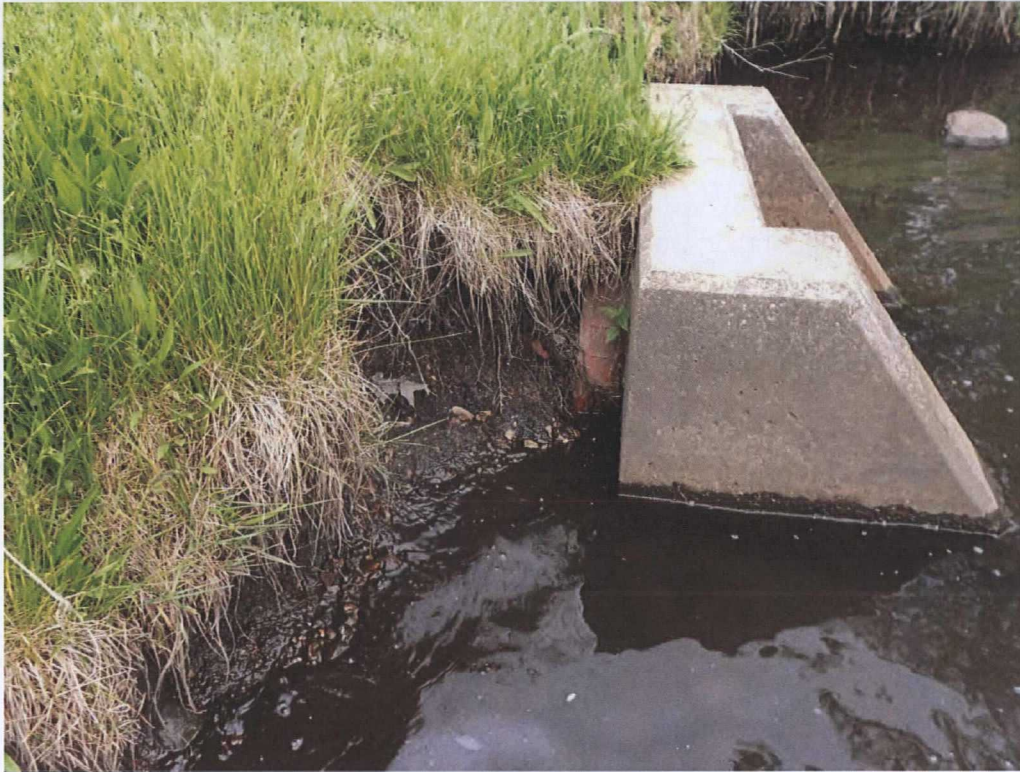
Bank erosion exposing clay pipe on the south side

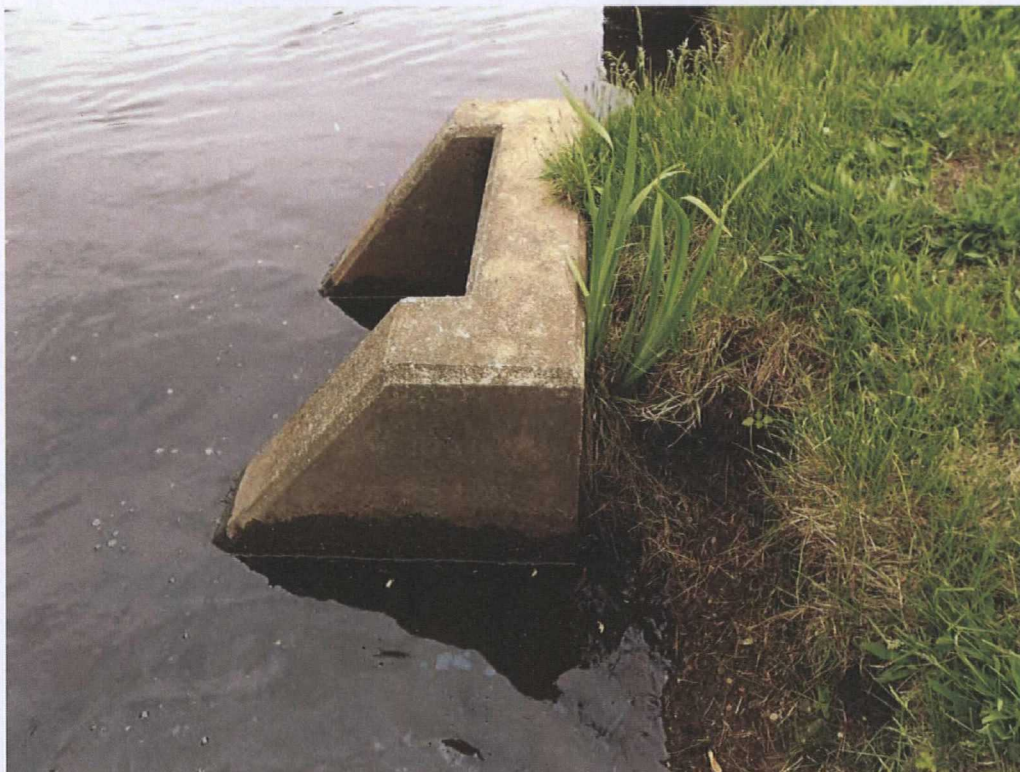
Bank erosion around north side of headwall

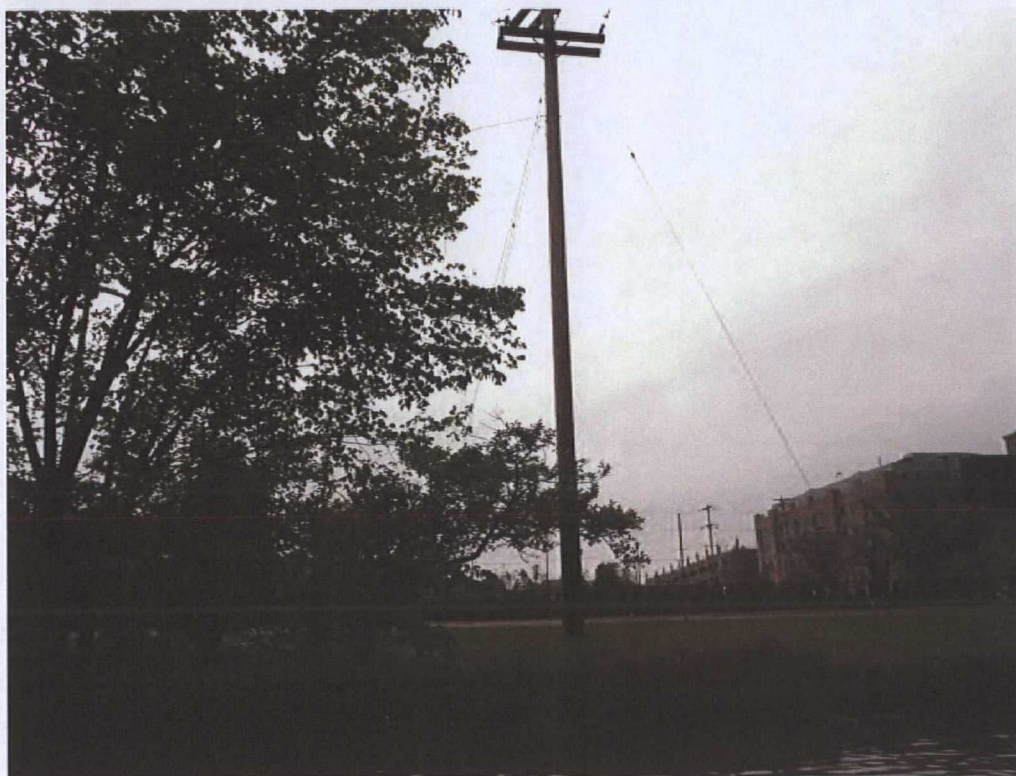
- No significant deterioration was noted.

View of the pole and guy from the channel

- Because of their distance from the excavation area (approximately 13'), the pole and guy will not be impacted by the excavation itself, however, they should be protected with construction fence or similar to make operators and drivers aware of their location.

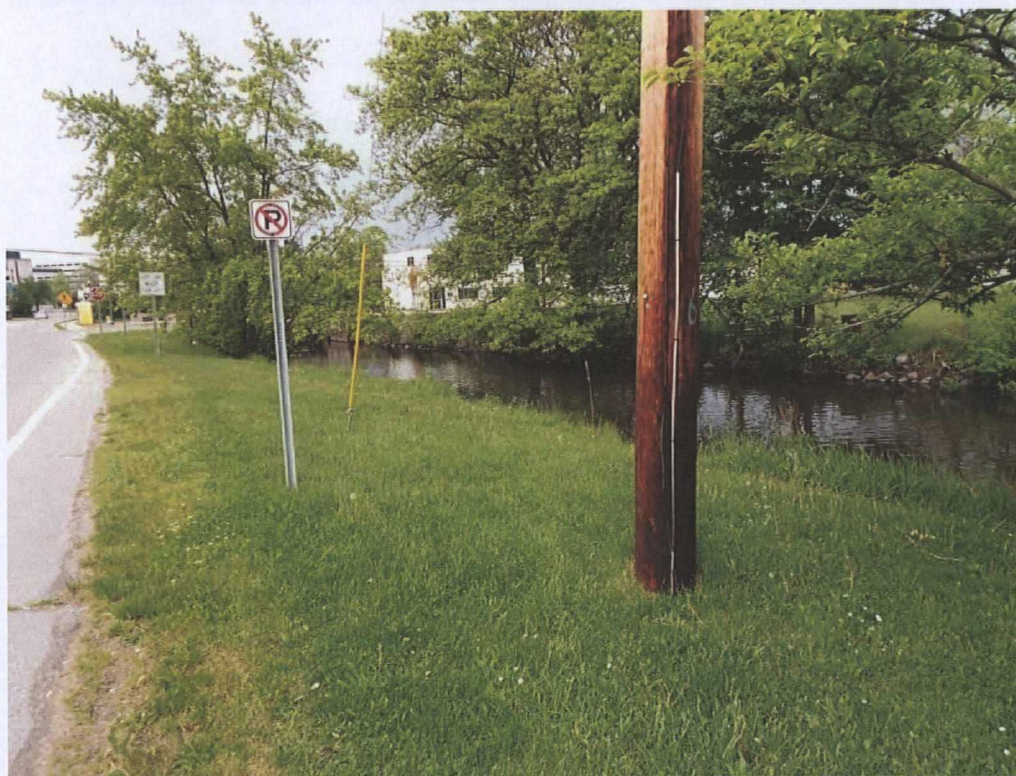
View of the pole and guy from the bank

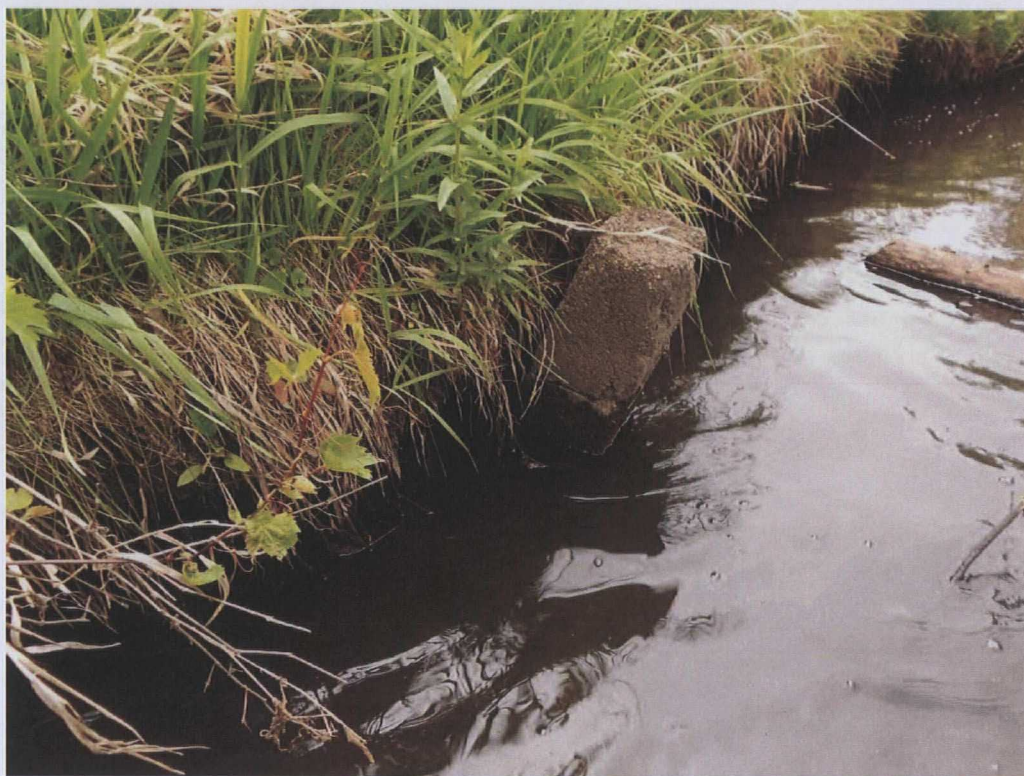
Post leaning severely toward the channel

- The purpose for the post is unknown and it can likely be removed in conjunction with sediment removal operations.

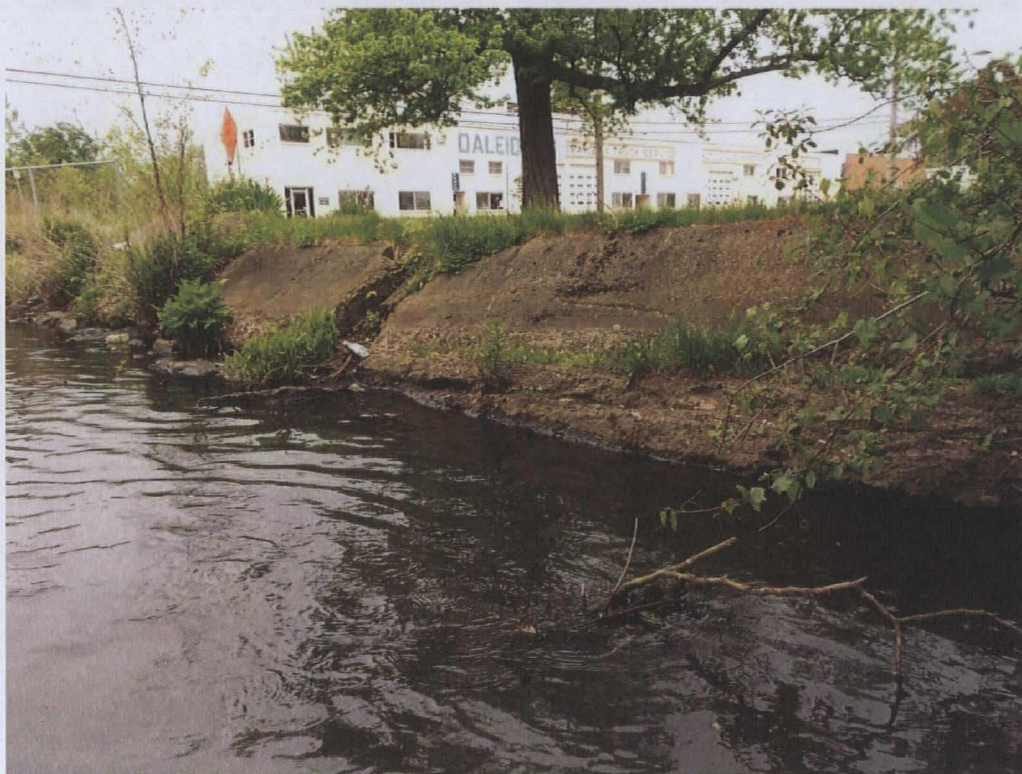
Vegetation growth through the structure

- Remove and replace the slabs as required to facilitate cofferdam installation and sediment removal.

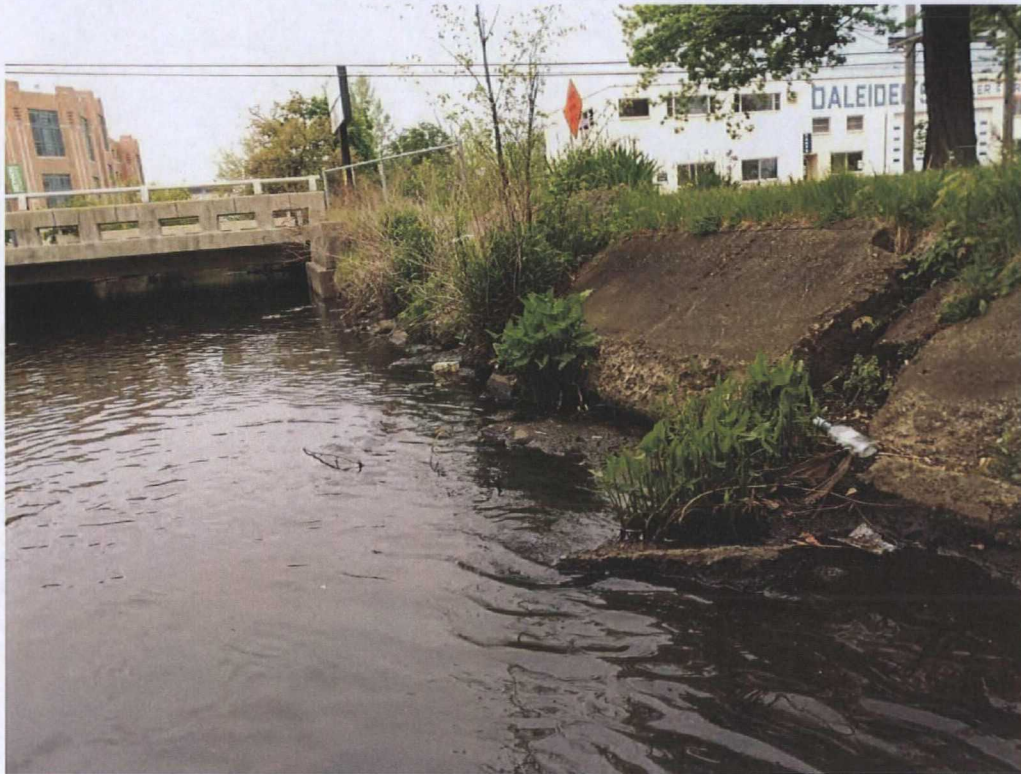
Vegetation growth through the structure

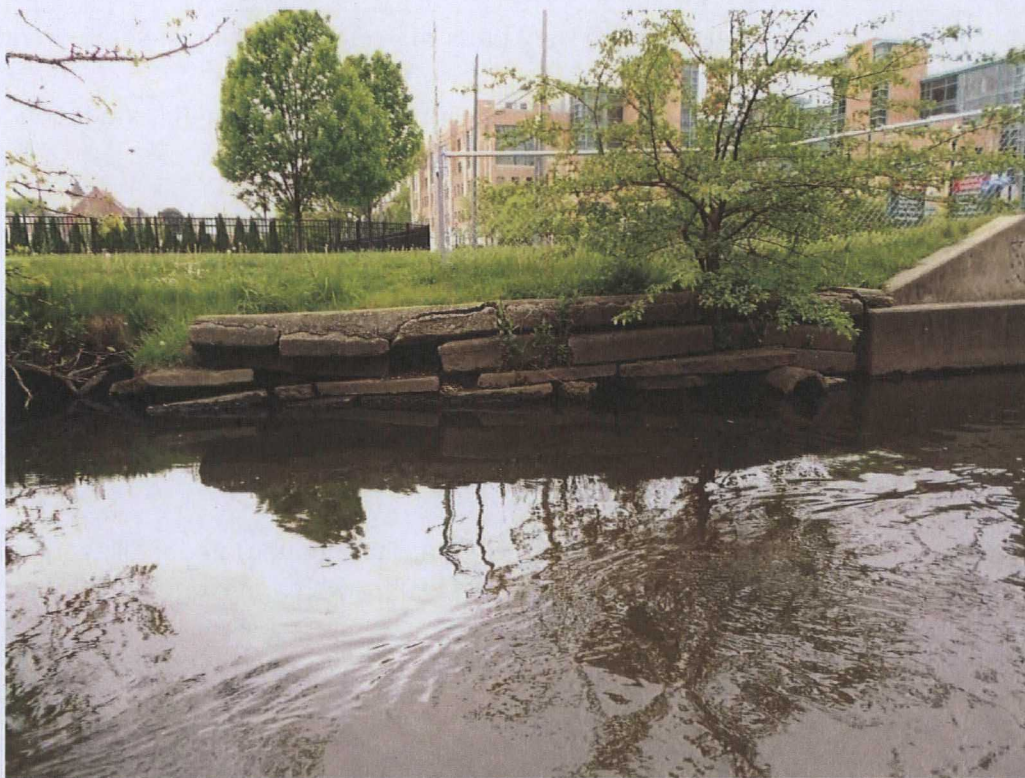
- The 12" concrete storm sewer outlet is severely abraded/spalled exposing the steel reinforcement.
- Slabs have severe cracking and settlement, approximately 2" at the southwest concrete wingwall of the Vine Street bridge.
- There is significant vegetation growth through the wall.
- The south end has severe bank erosion with a sink hole behind the wall.

View of the structure from the channel

- Remove and replace the slabs as required to facilitate cofferdam installation and sediment removal or extend the cofferdam around the structure with approximately 4' clearance.
- Protect the storm sewer outlet with a cofferdam to allow for dewatering. Because of its proximity, the cofferdam will likely be part of the cofferdam for the Vine Street bridge.

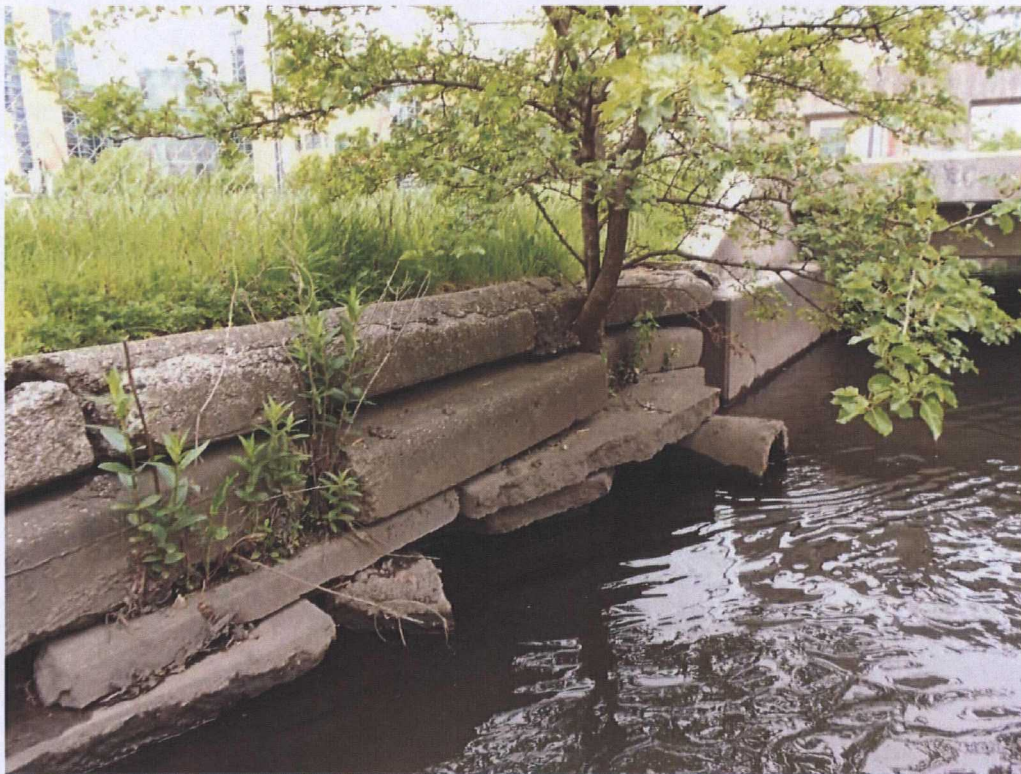
Tree growth in north area of the wall near the storm sewer outlet

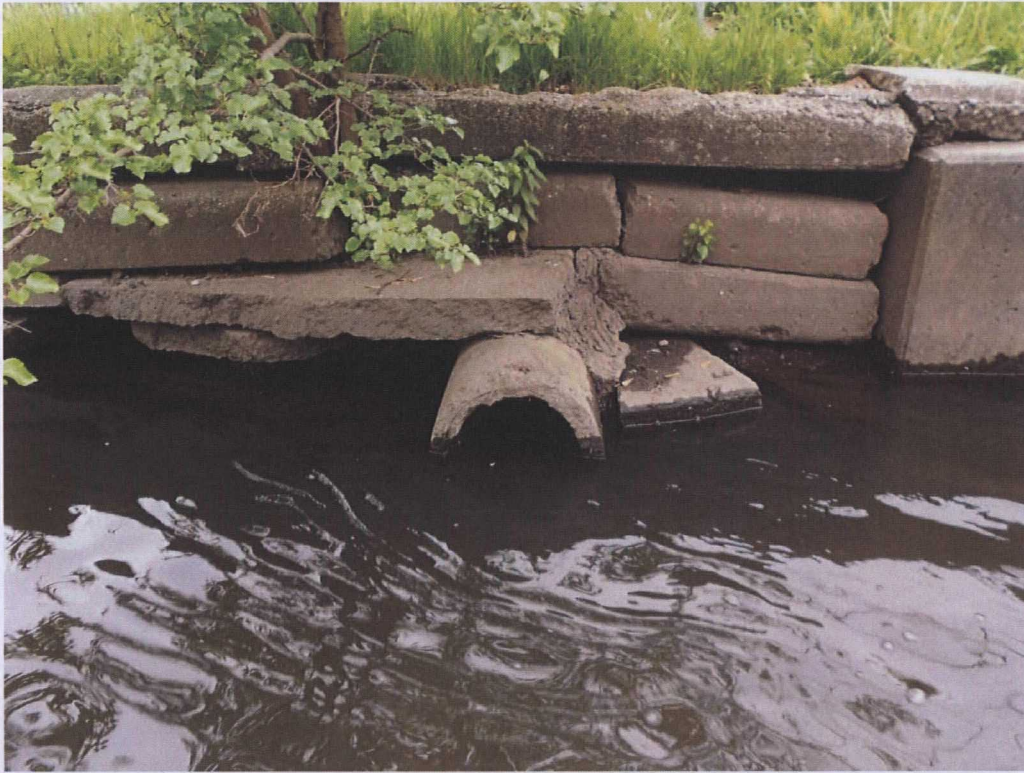
Storm sewer outlet through the wall

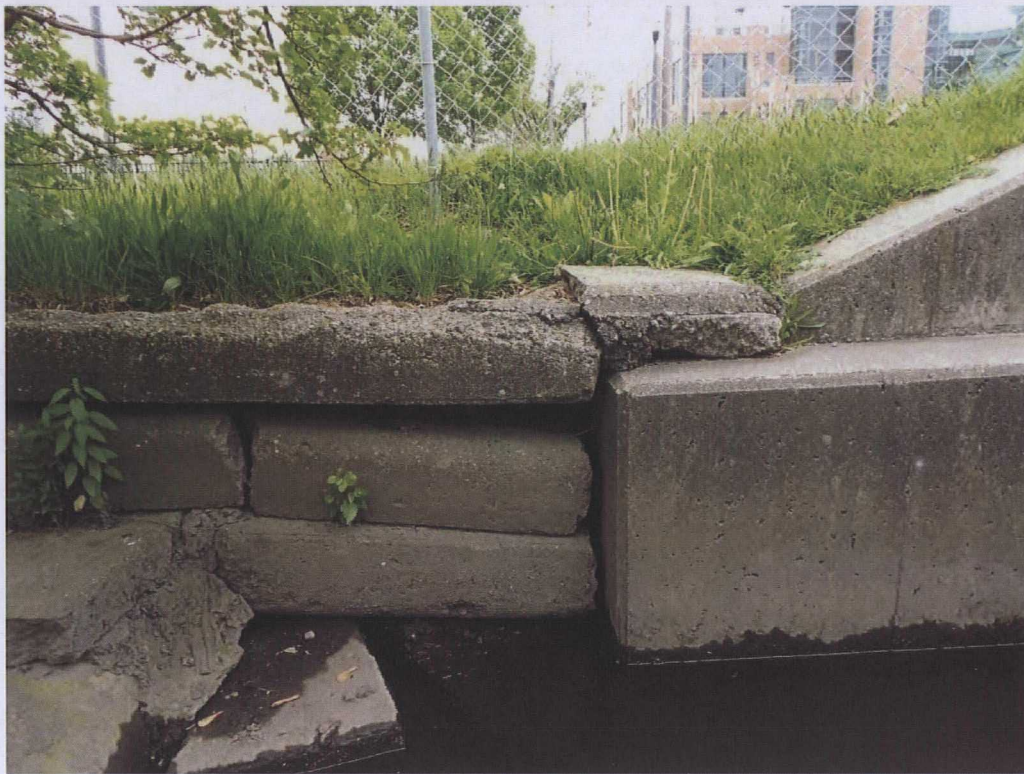
Settlement of the concrete slabs at the Vine Street bridge

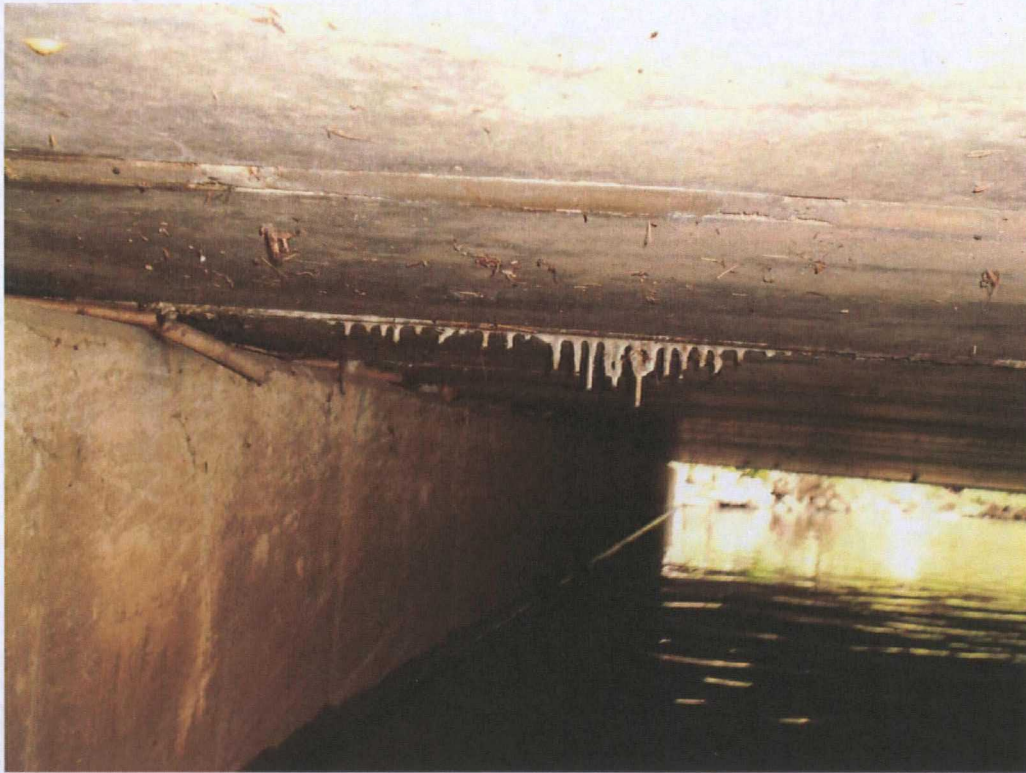
- Efflorescence and stalactites were noted along several box beam joints.
- The banks are protected by concrete rubble walls in the southeast and southwest.

Efflorescence and stalactites along box beam joint

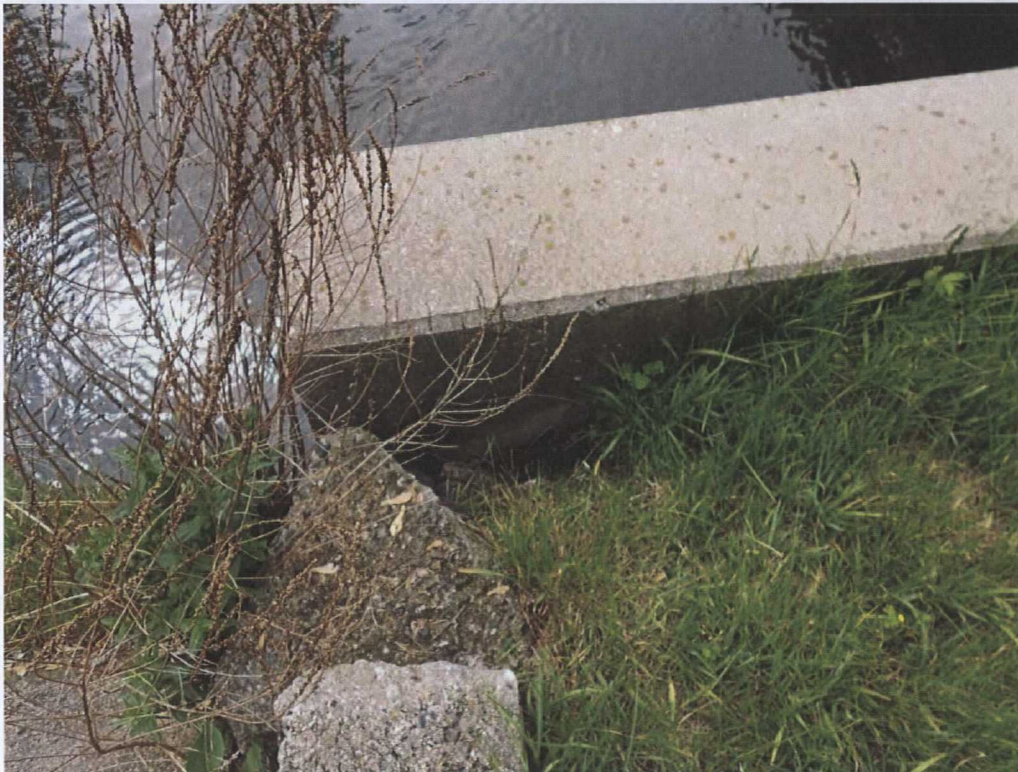
Bank erosion around the southeast abutment

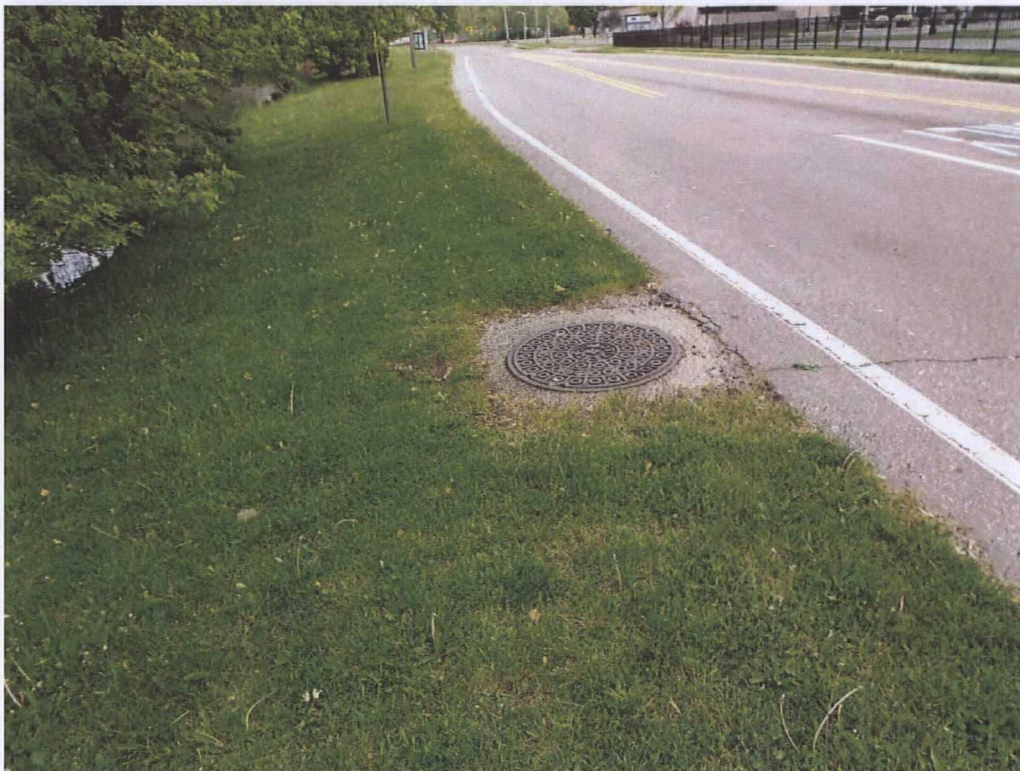
Electric vault in the southwest

- During evaluation, equipment was not available to access the electric vault in the southwest quadrant along Jasper Street. Mapping of the area's electric facilities have been requested but are not yet available. Therefore, it is recommended that the vault be opened prior to work in the area to check whether there are underground facilities suspected of crossing beneath the channel in this area. Utility mapping will be reviewed when it is received and an update provided.
